World War II Memorial

World War II
Memorial
Morrow Park
Pittsburgh, PA

Project
Duration:
May 2007

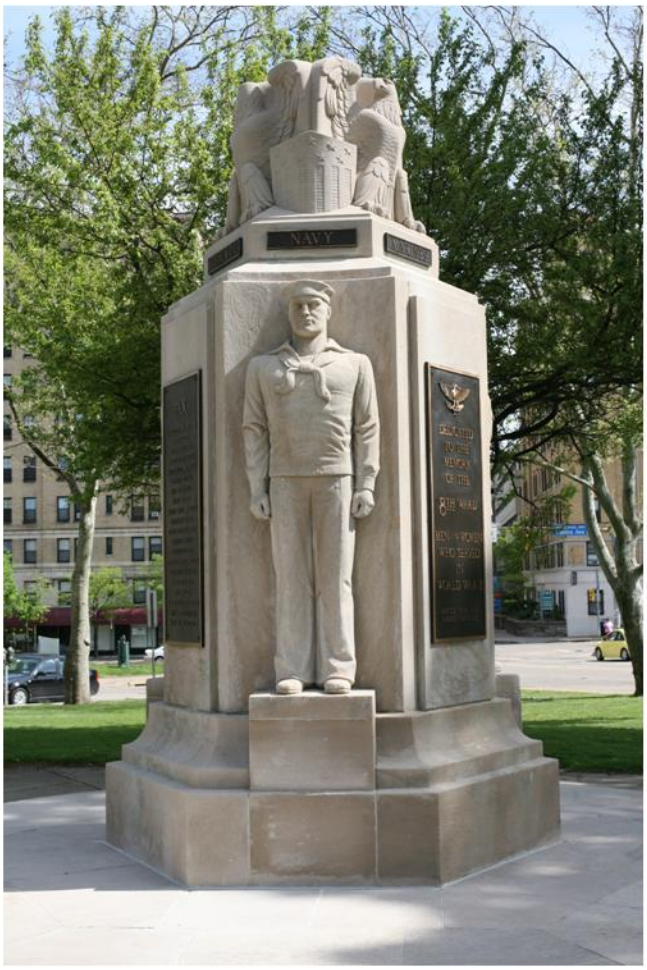
The ICA was retained by Pittsburgh's Department of City Planning to assess and treat a 1949 limestone memorial with bronze plaques by artist Frank Vittor. The limestone had suffered from erosion over time, possibly from a combination of previous cleaning treatments and weathering. The monument was also suffering from discolorations due to copper staining, lichen growth, and a number of unsightly older repairs made with materials that no longer matched the color of the original sculpture.

ICA conservators photographed and documented the monument's condition, repaired deteriorated mortar, replaced mismatched earlier repairs, cleaned the limestone, and cleaned and waxed the bronze plaques.
